news@brigantinegroup  
May 2010

## Structural Failure Causes Concerns...

## When the Unexpected Happens – A Boom Articulation Replacement Job Sharing

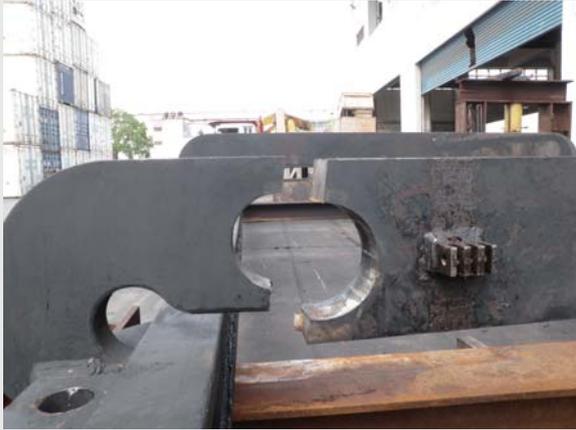
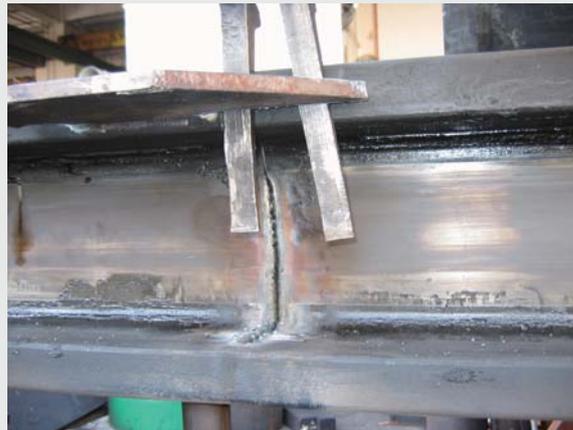
Cracking is commonly found on these mobile equipment units due to the following reasons:

### 1.High mobility and manoeuvrability

They are used to travel longer distance, with higher speed and have to engage tight turns with large loads. Such kinds of frequent movement and various loads are the main cause of extreme wear and tear and/or cracking.

A number of these machines are run on unpaved ground, even though they are not designed to do so. It is common to see the depots located in rural areas or places where surfaces of the ground are not paved. Those tough working environment will cause some unnoticeable problems of the equipment due to the irregular/uneven stress on the structure.

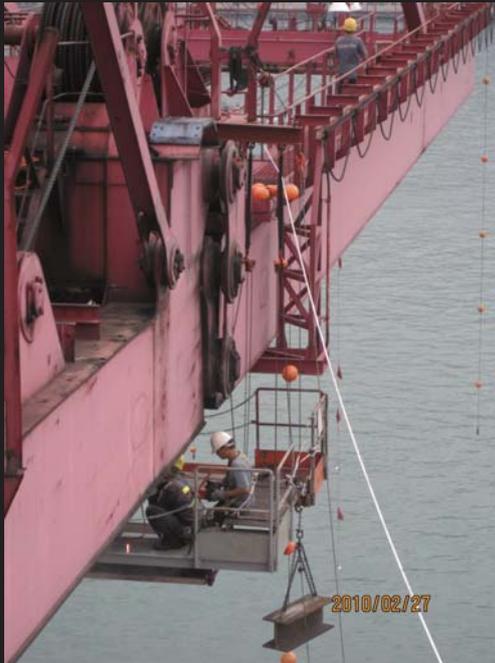
Our Equipment Maintenance Department received a repairing contract earlier this year to replace the boom articulation pin and bush on a goose neck quay crane in Hong Kong. We were provided with the working procedures to follow and expected to complete the work within seven consecutive working days.

We did a large amount of preparation work, including the erection of the block and tackle system for transferring material between the working area and the quay deck, setting up of the working platforms and fixing the jigs for pin extraction. Everything went smoothly and as planned during the first three days.

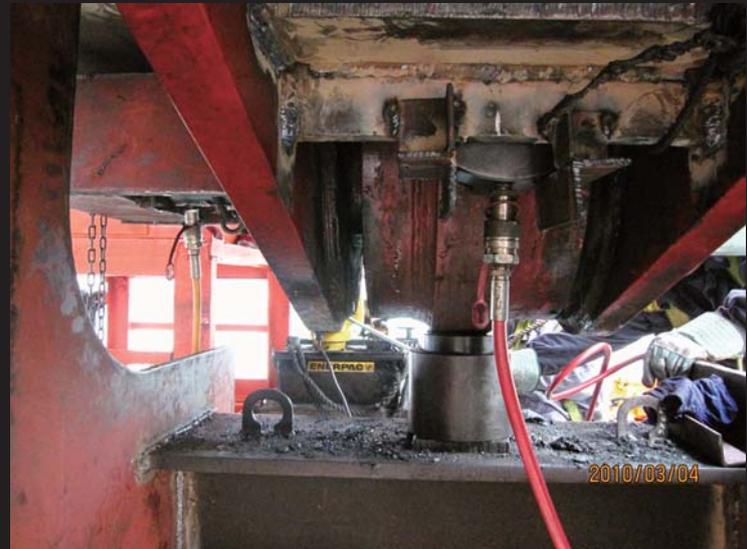
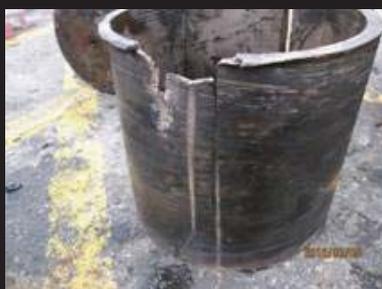
The pin was caught by the seriously worn bushing, so without cutting the bushing open, it is impossible to take the pin out. However, the traditional oxy-acetylene flame cutting or carbon air arc gouging is not efficient for the job, and after many technical discussions, we decided to deploy the termite cutting tool which uses pure oxygen and aluminium cutting rod that speed up the process. After the pin and bushing were removed, the rest of the process was completed according to our plan.

Troubles came to us when we were going to extract the pin, after we finished the preparation work. As stated in the procedures, the boom can be leveled, in both vertical and horizontal directions, jacked by two 50-tonnes capacity hydraulic jacks at the chosen position, but it turned out that the jacks had no effect against the weight of the boom when we tried. The hinge pin was squeezed by the weight of the boom and it was impossible to move it even one millimeter.

The time kept slipping away, and the terminal engineering staff and we went through many other options to look for the best solution to solve the problem but only in vain. So, we decided to start trying with a 250-tonnes capacity hydraulic jack and it finally worked. The pin was able to be extracted inch by inch. However, before we could celebrate the success; the boom stopped moving after few centimeters and showed no signs of further movement.
